# Lionel Motor Binding Repair

## Root Causes

## Lionel Motor Binding Repair Corrective Action

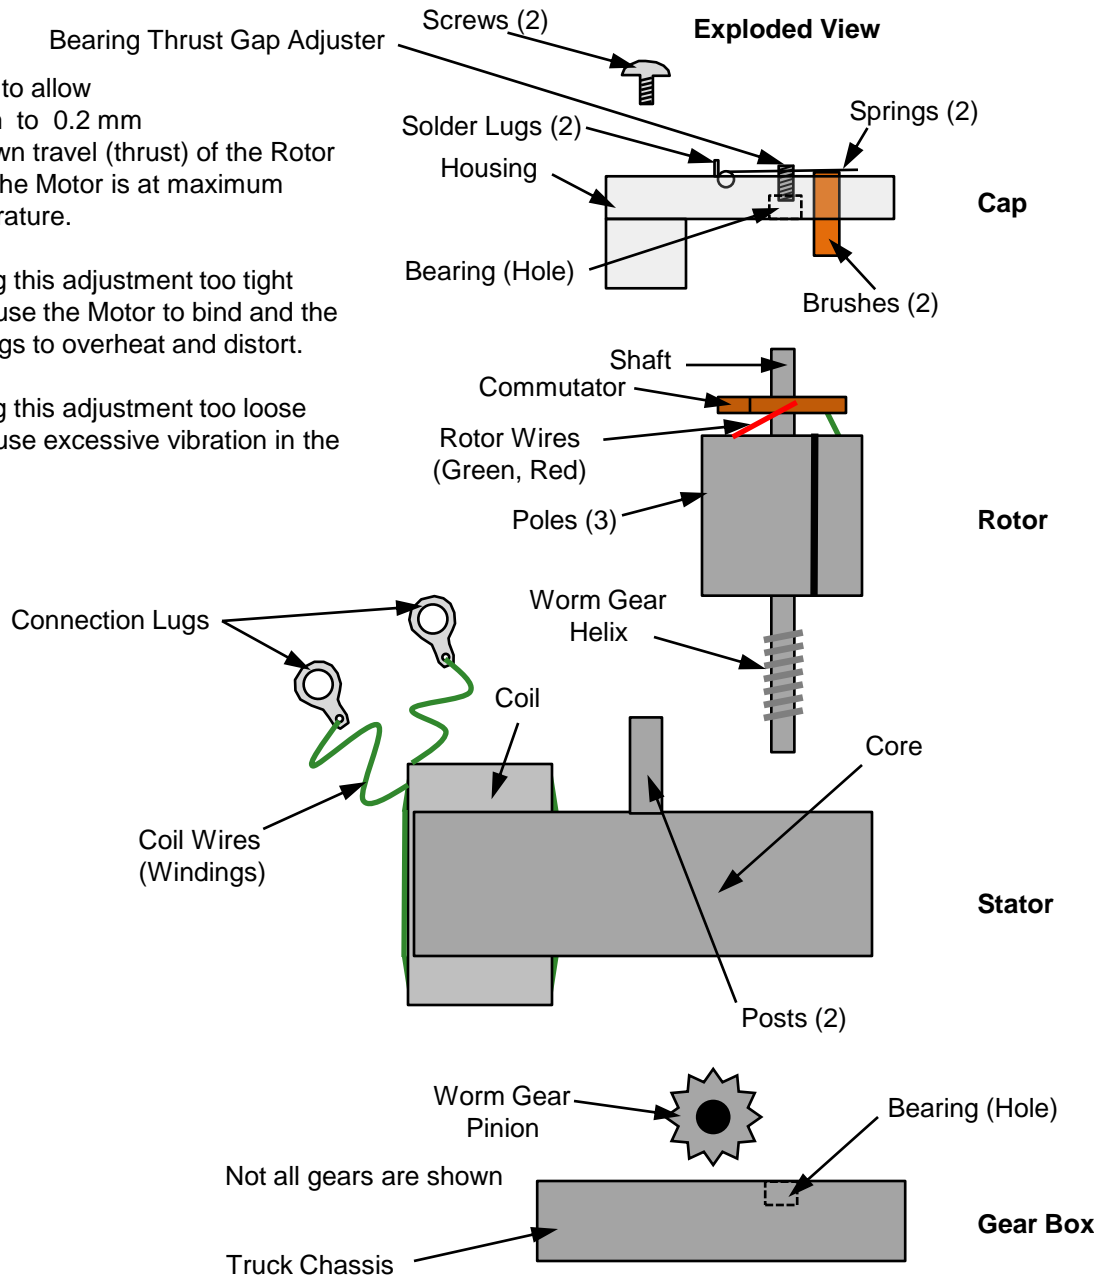
### Exploded View

Adjust to allow  
0.1mm to 0.2 mm  
Up/down travel (thrust)  
of the Rotor when the  
Motor is at maximum  
temperature.

Making this adjustment  
too tight will cause the  
Motor to bind and the  
Bearings to overheat and  
distort.

Making this adjustment  
too loose will cause  
excessive vibration in  
the Motor.

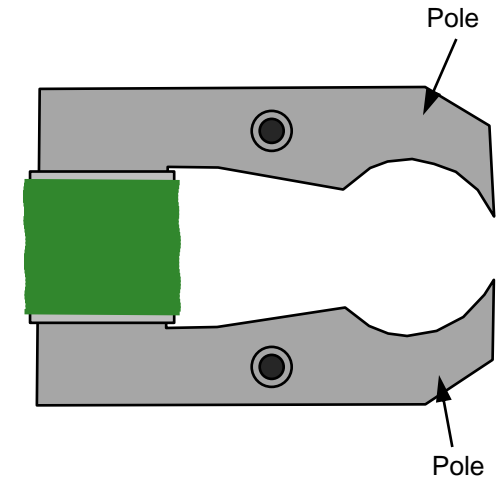
To get the motor to maximum temperature:  
Run the motor at 75% voltage with the maximum  
expected load (hottest day, steepest grade, and  
highest number of rolling stock) for 10 minutes,  
then let sit (all power off) for one minute. This is  
because the spinning of the Rotor actually cools  
the Motor by convection. The Motor reaches  
maximum temperature only a short time after  
stopping in these worst case conditions.

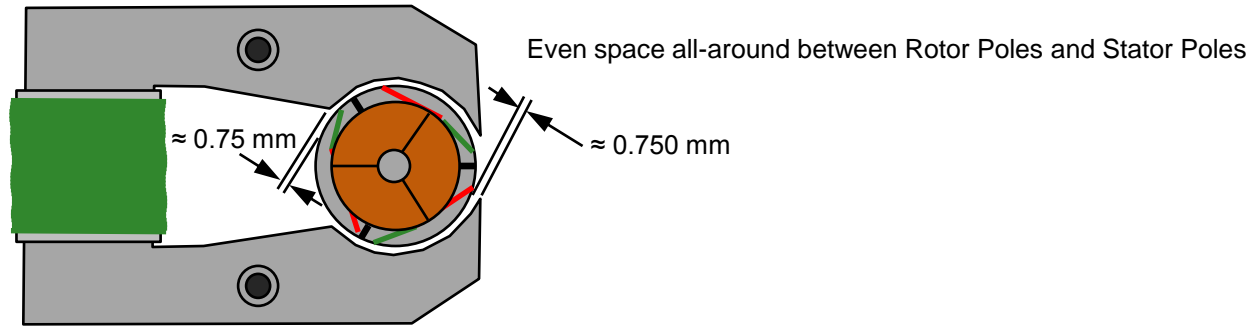
**Normal**

***Cold (Room Temperature) Motor***

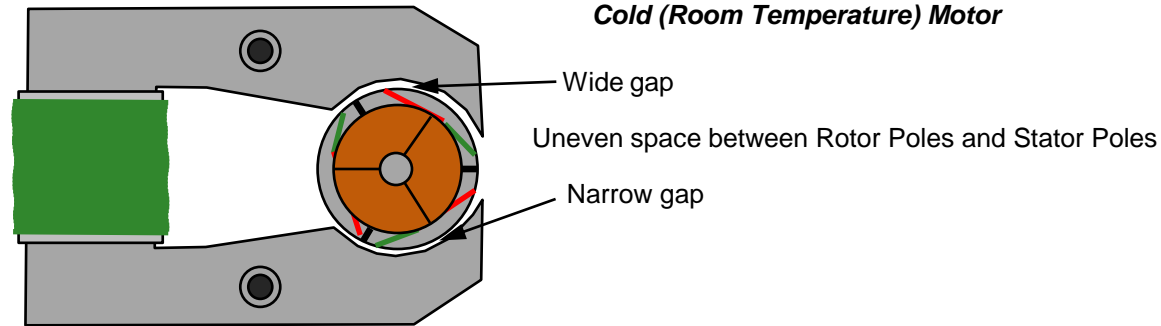
**Faulty**

***Cold (Room Temperature) Motor***

Three causes of Rotor misalignment:

1. Stator Distortion due to heat/cool cycles
2. Post Vertical Bend due to heat/cool cycles
3. Bearing Wear
4. Cap Distortion due to heat/age

Any one or more of these can contribute to Rotor misalignment, however, Cap Distortion is the most prevalent.

Sand the inside of the Stator Poles smooth (remove no more than 0.100 mm) to increase the gap between the Stator and Rotor. Block off all gear areas to keep debris out of the gears. Wash away debris with 97% Isopropyl Alcohol and blow away any residue with Compressed Dry Air (CDA).

Gently tap the posts to new angles to move the Cap (and thus the Rotor) away from the closest side of the Stator. Only a very slight bend (virtually undetectable to one's eye) to the posts is all that is normally required. Note, bending the posts may cause some tightness in the Rotor at the bearings. If the posts were bent only slightly and the Motor seems to run well at slow speeds, the bearings should resettle to the new alignment configuration. This may require several Heat/Cool cycles of the Motor to completely settle the bearings.

Push apart the Stator Poles no more than 0.100 mm. This requires special mechanical tools that are expensive and not normally found in a hobbyist's workshop.

If the Bearings are worn (determined by loose and/or excessive wobble of the Rotor), the Bearings may be over-drilled out slightly, scuffed inside, and filled with metal reinforced epoxy (J-B Weld 8265S). Then new Bearings hole are drilled into that epoxy. This requires precision milling machines that are not normally accessible to the general public. It is best to replace the entire Cap Assembly if the upper bearing is worn, and replace the Truck Chassis if the lower bearing is worn.

Sand the outer surface of each Rotor Pole smooth (remove no more than 0.075 mm) to increase the gap between the Stator and Rotor. Wash away debris with 97% Isopropyl Alcohol and blow away any residue with Compressed Dry Air (CDA). The metal from each pole must be removed evenly from all 3 poles to maintain dynamic (spin) balance of the Rotor when the Motor operates. A slight imbalance may be tolerated since the Motor does not spin at extremely high speeds and the relatively small diameter of the Rotor does not amplify imbalances.

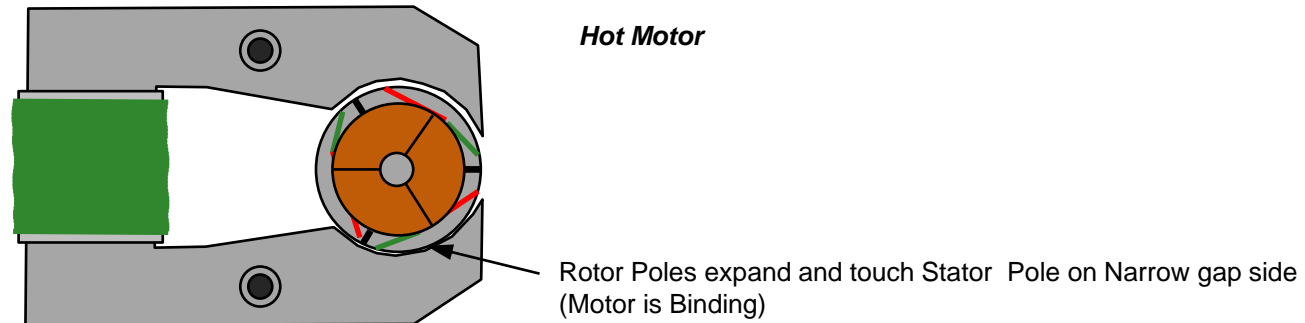
**Failure**

***Hot Motor***
